Deterioration mechanisms of historic cement renders and concrete

Isobel Griffin. MA (Hons)

A thesis submitted to the University of Edinburgh
for the Degree of Doctor of Philosophy

July 2013

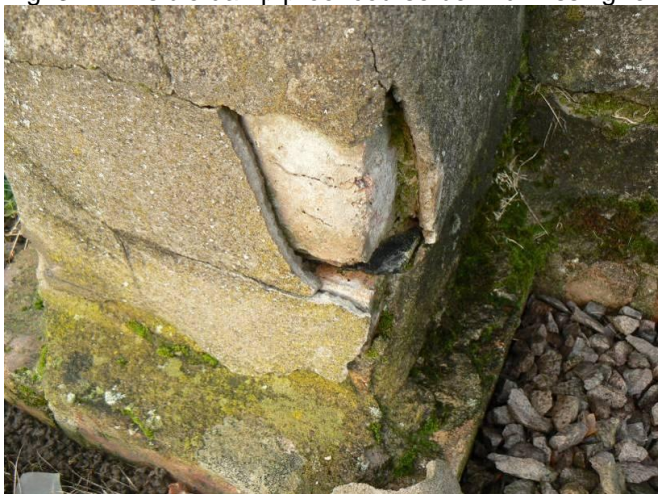
Fig. 3.11. Visible damp proof course behind missing render on Building 22

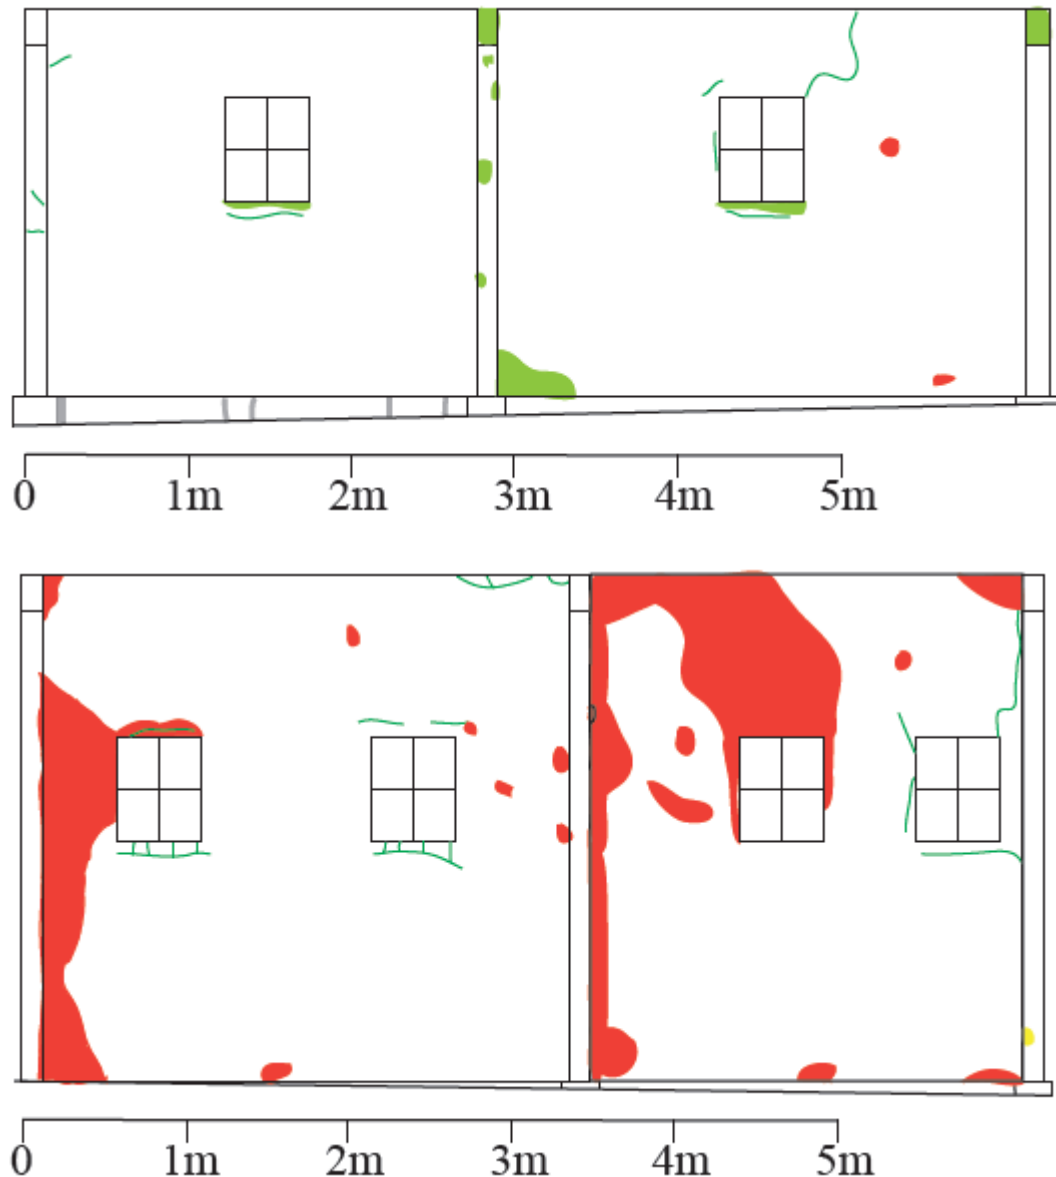
Fig. 4.4. NE and SW elevations of Building 46, showing that flaking of the render (red) occurred predominantly on the SW elevation

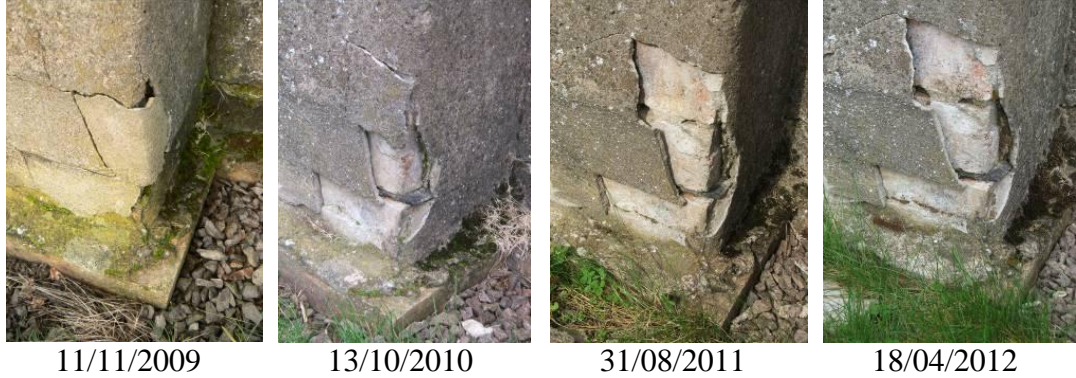
Fig. 4.7. Building 22, delaminating render on the first pier from NW on the NE elevation

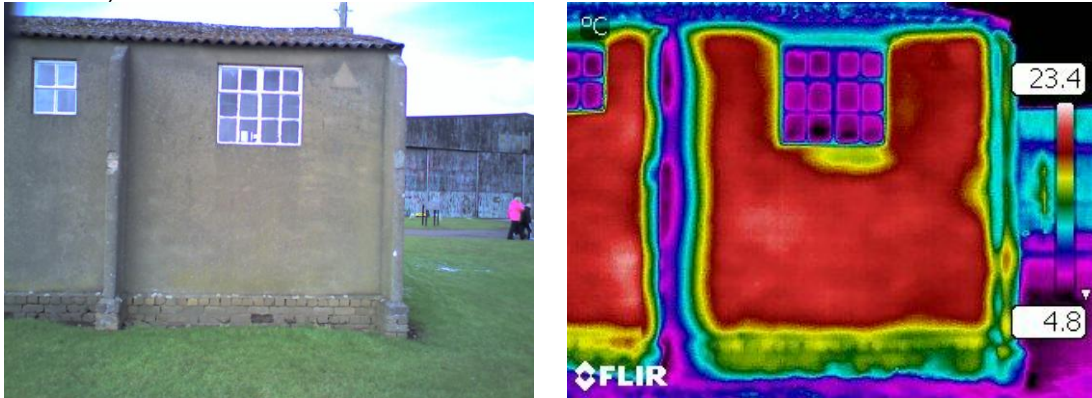
Fig. 4.14. Building 31, SE elevation, infrared thermograph showing cooler areas under the windows and on the piers, corresponding to higher moisture content. The infrared thermograph is a false colour image showing the surface temperature of surfaces in °C, where the red areas are warmest and the purple areas are coolest (Maureen Young, Historic Scotland)

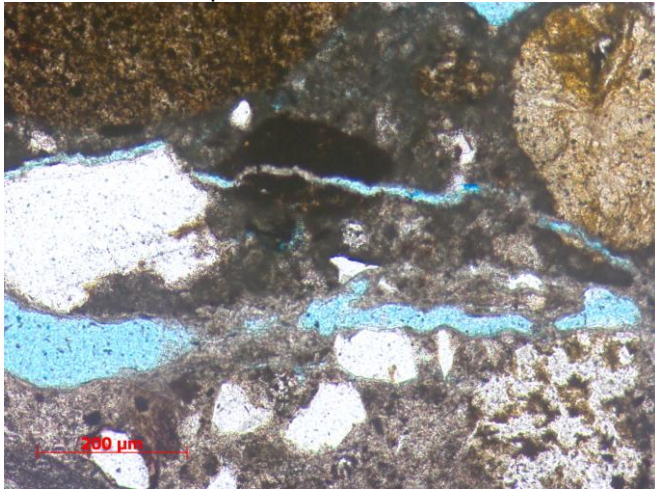
Fig. 5.10. A crack parallel to the brick interface in B32 OR, running through a weak aggregate particle (render in upper half of image, brick in lower half), plane polarized light, field of view: 875 μm across

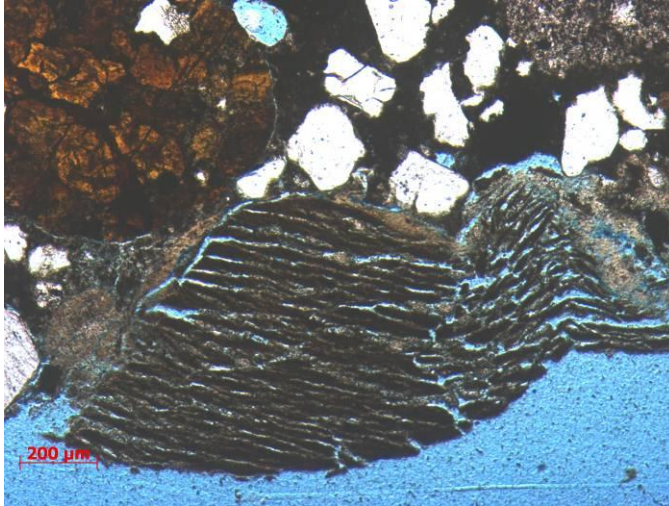
Fig. 5.20. The mudstone aggregate on the bottom of the Building 47 blister, plane polarized light, field of view: 1750 μm across

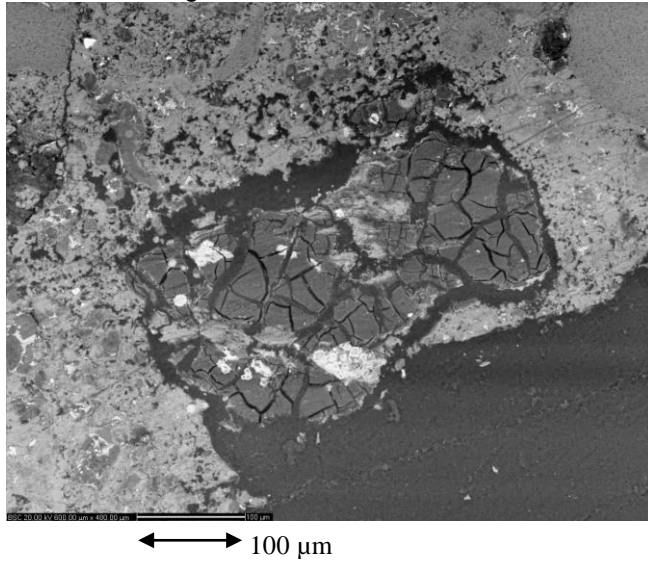
Fig. 6.3. SEM micrograph showing a shrunken, cracked particle in B25 OR, which may have caused cracking within the render

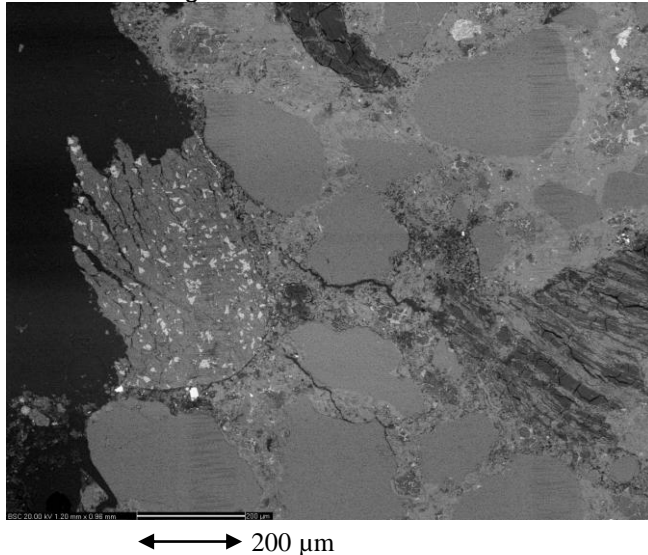
Fig. 6.4. SEM micrograph showing a layered particle in B25 OR, which appeared to have caused cracking within the render

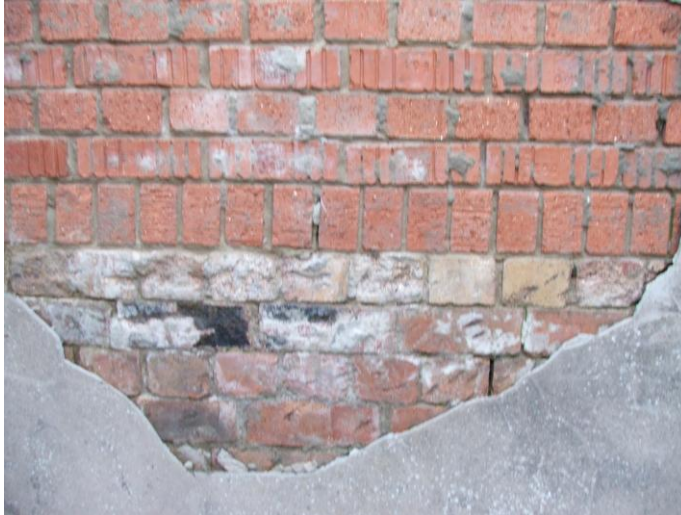
Fig. 9.1. The rebuilt wall in the Electricity Sub-Station, showing the boundary between the old and new bricks

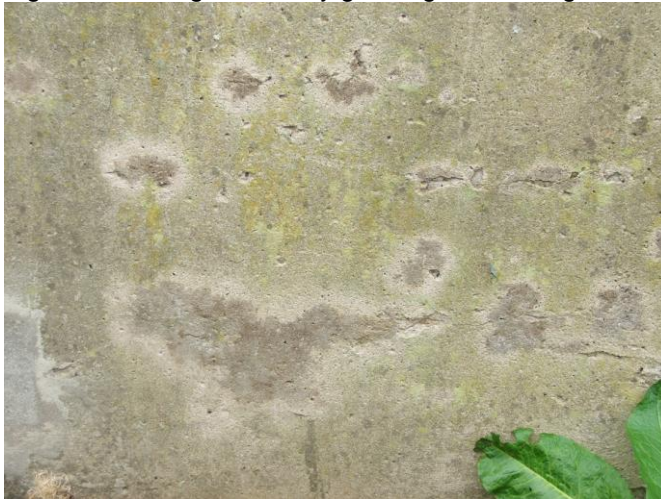
Fig. 9.3. Staining caused by grouting on Building 25

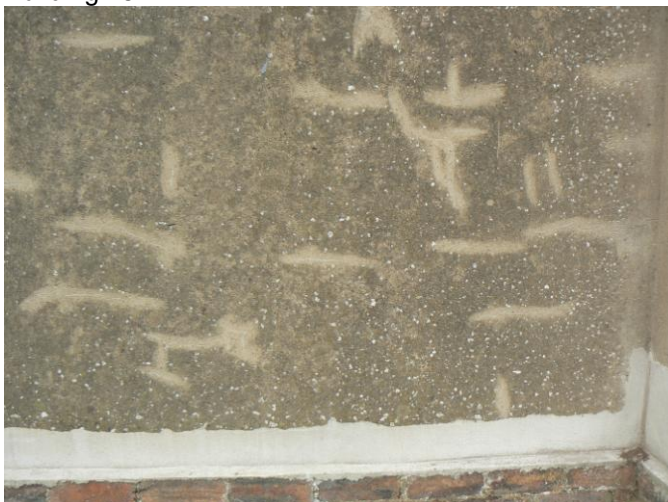
Fig. 9.4. Patchy appearance caused by cleaning around cracks prior to filling them, again on Building 25

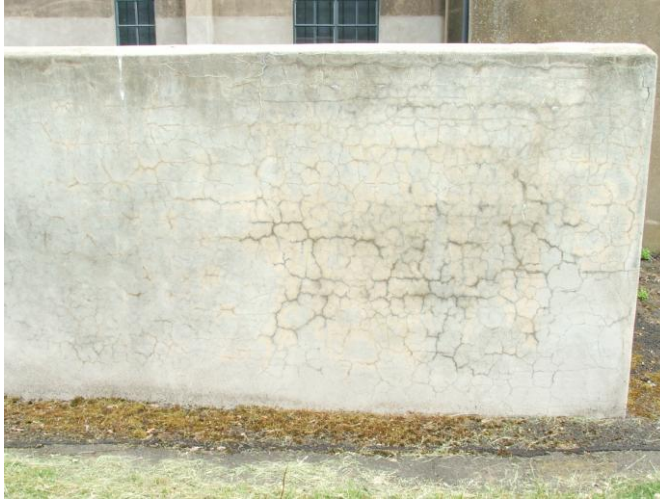
Fig. 9.8. Cracking of the repair render on the free-standing wall behind Building 25

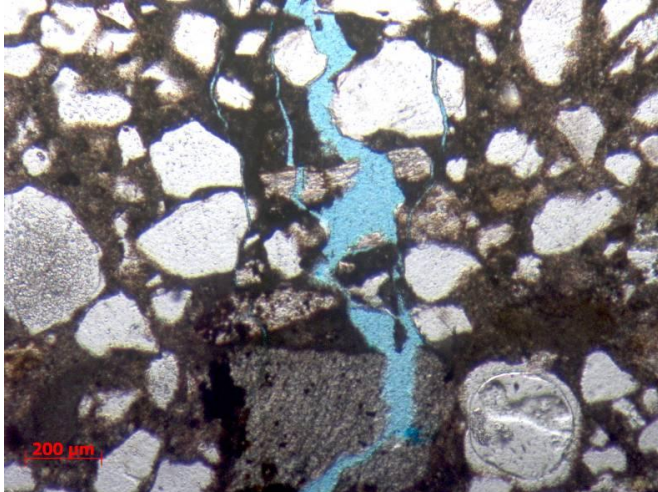
Fig. 9.15. Drying shrinkage crack running perpendicular to the surface of B25 RR (surface at top of image), plane polarized light, field of view: 1750 μm across

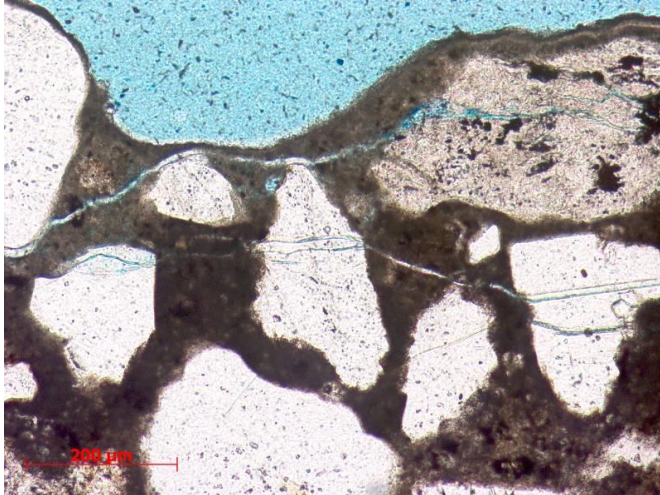
Fig. 9.16. Smoothed surface finish of B25 RR (surface at top of image), with cracks running parallel to the surface, plane polarized light, field of view: 875 μm across

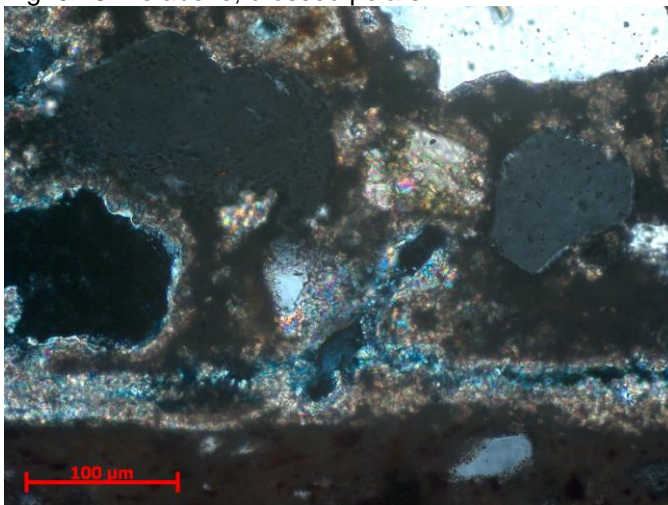
Fig. 9.17. Voids filled with portlandite and calcite crystals along the interface between B25 RR and the brick (render in upper part of image, brick in lower part), plane polarized light, field of view: 440 μm across

Fig. 9.18. As above, crossed polars

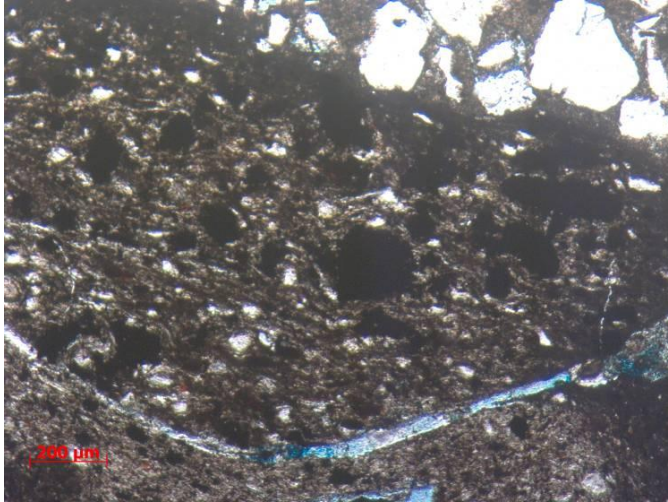
Fig. 9.19. Cracking in the brick close to the interface with B25 RR, plane polarized light, field of view: 1750 μm across

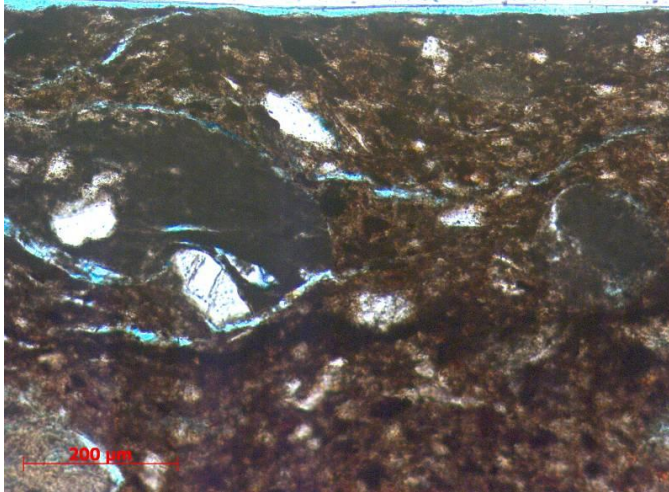
Fig. 9.20 Smooth surface of the modern brick from Building 23 with fine cracks parallel to the surface (at the top of the image), plane polarized light, field of view: 875 μm across

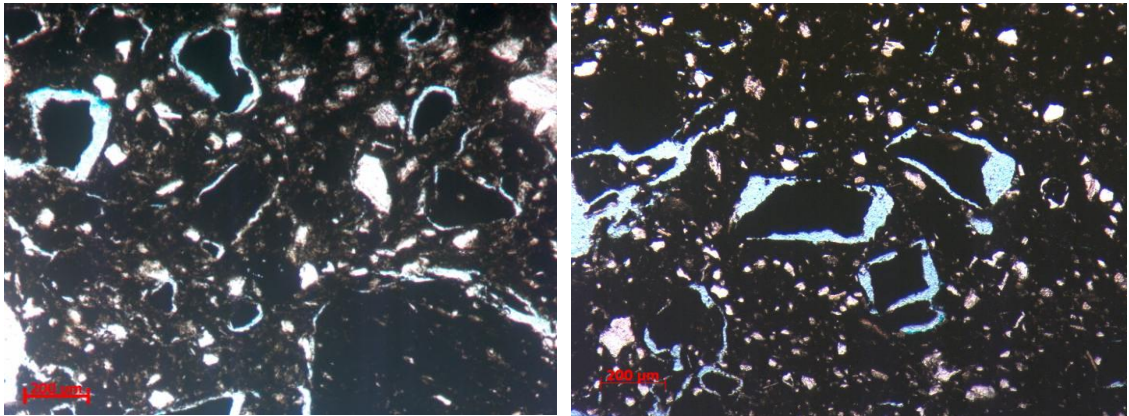
Fig. 9.21. Shrunken mudstone fragments in the Wallyford bricks (left) and the bricks from underneath B25 RR (right), plane polarized light, field of view of each image: 1750 μm across

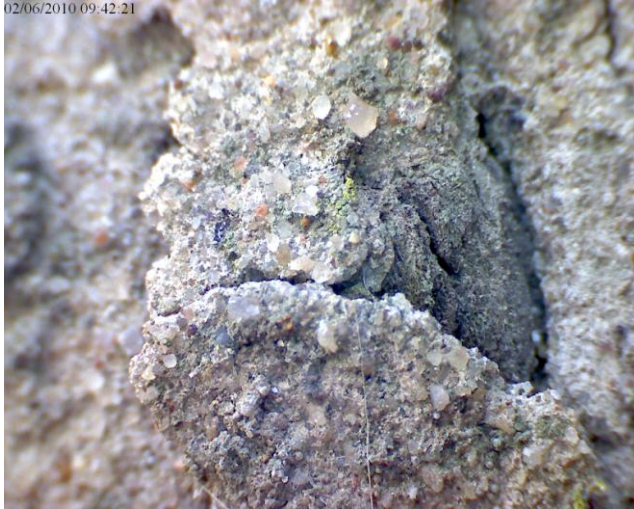
Fig. 10.6. Detached blister of render on Building 25, with fractured grey aggregate particles visible inside

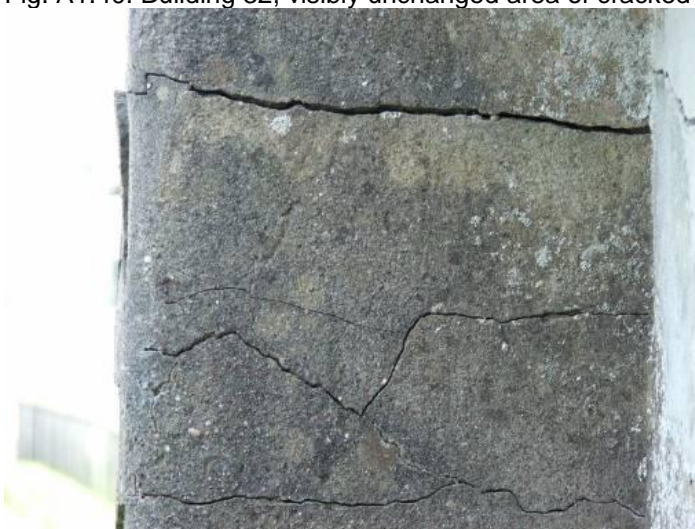
Fig. A1.40. Building 32, visibly unchanged area of cracked render (18/04/2012)
